1. Tree branch laid across water course
2. Sheep Hurdles, including fences and gates installed across Water course, along with a low bridge across the water course (See below images)
3. Further sheep fencing and mesh across the water course, along with some farm rubbish including tractor tyres.
4. Narrow bridge brick arch which is restricting flow and means large amounts of debris is been dropped as shown in the images.
5. Agricultural ford crossing
6. Agricultural ford crossing across river
7. Unknown wooden bridge disused and overgrown. Looks rotten and may give way in the future.
8. Fallen Trees in water course perturbing from the bank and low hanging bushes.
9. Damage to bridge separation between arch and parapet

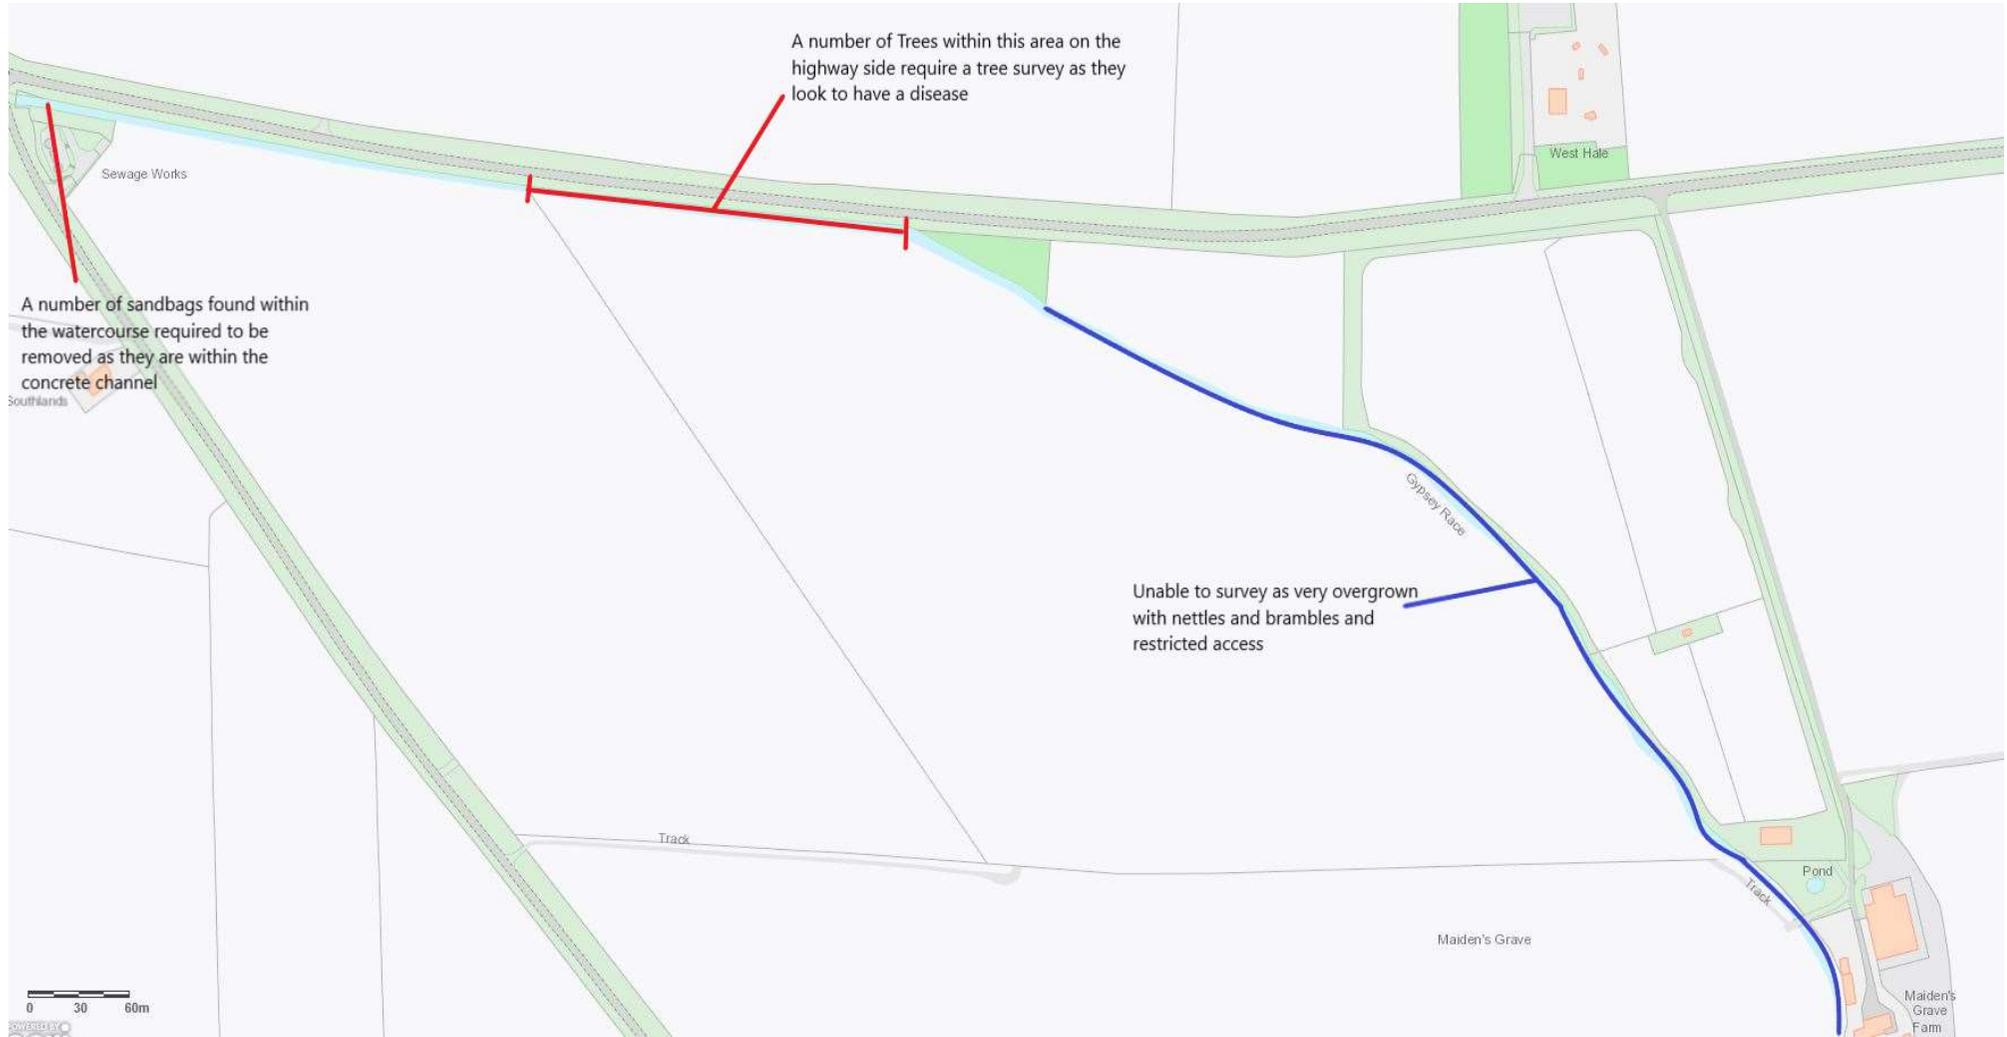
A number of Trees within this area on the highway side require a tree survey as they look to have a disease

A number of sandbags found within the watercourse required to be removed as they are within the concrete channel

Unable to survey as very overgrown with nettles and brambles and restricted access

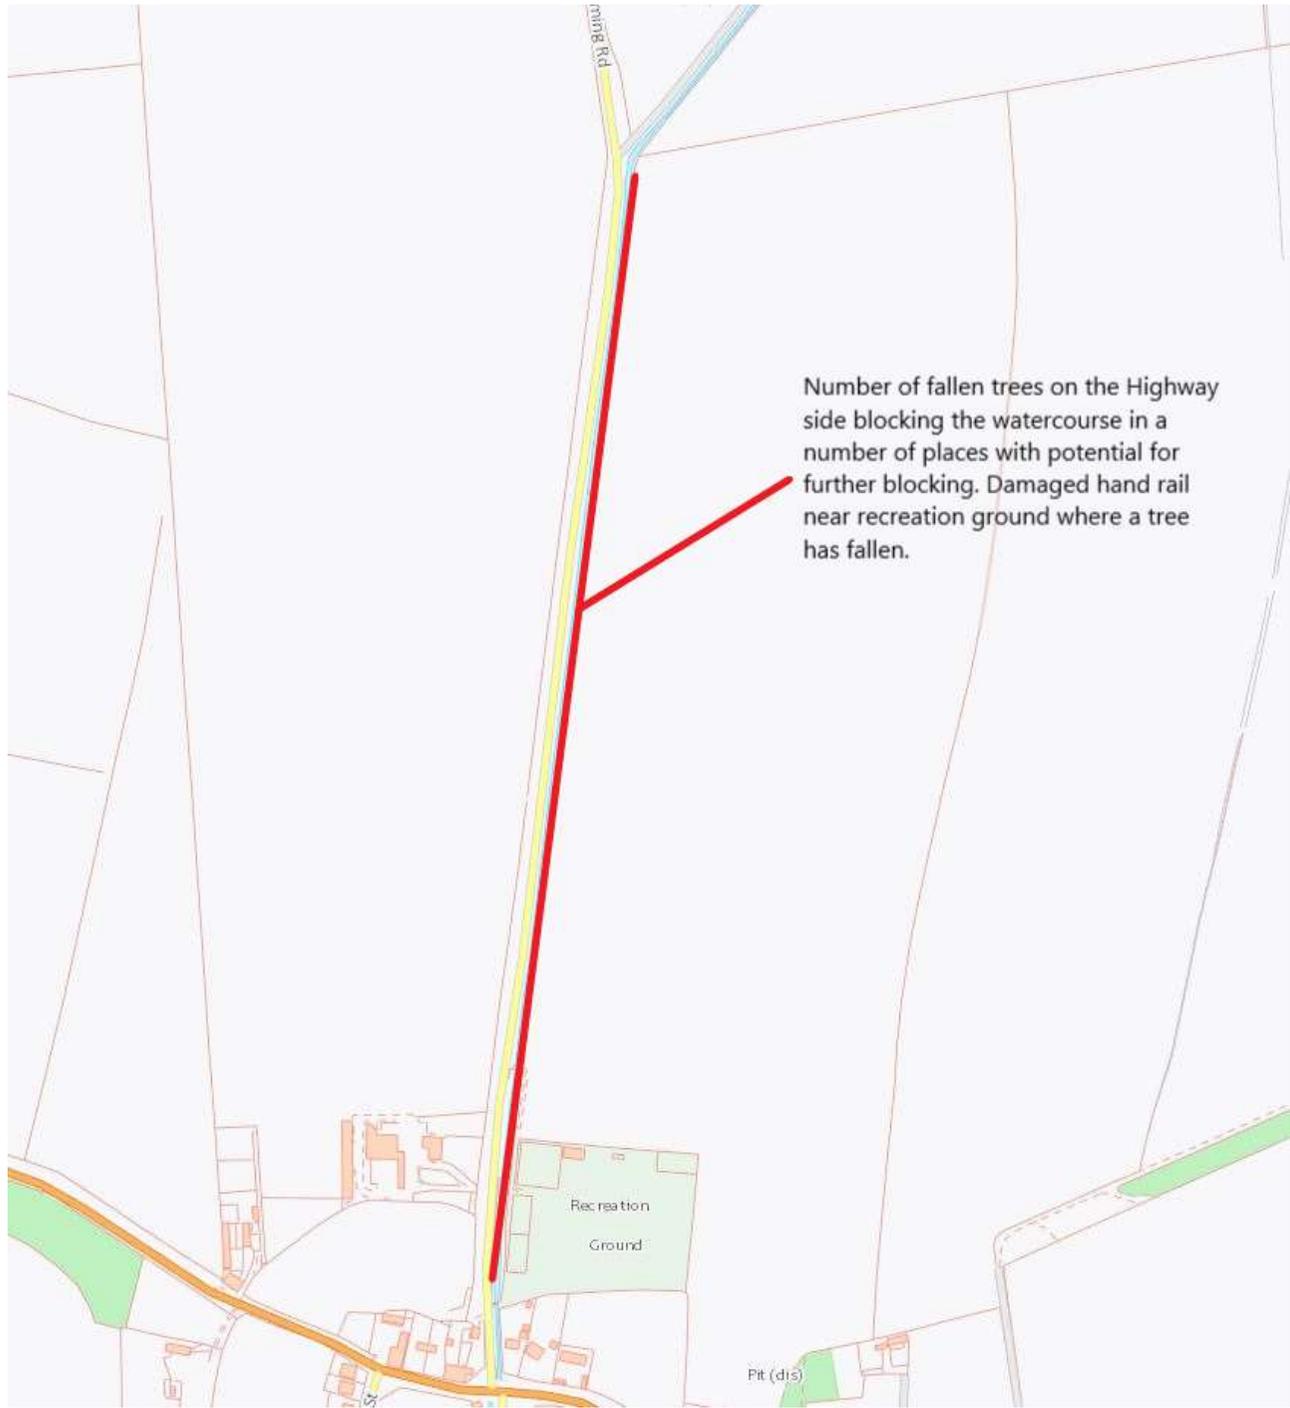
Number of fallen trees on the Highway side blocking the watercourse in a number of places with potential for further blocking. Damaged hand rail near recreation ground where a tree has fallen.

Overgrown with small trees and bushes requires some maintenance
